Excessive Seepage Losses at Westwood Lake Dam

SYNOPSIS: Excessive seepage losses at Westwood Lake Dam in east-central Indiana were apparent in 1974 during first filling of the lake when seepage areas developed downstream of the dam and abutments. Several remedial studies were performed which included additional test borings, field and laboratory tests, installation of observation wells, and a review of the site geology and hydrology. Data and observations from these studies were used to develop semi-quantitative assessments of seepage loss rates as related to lake levels. These analyses served as a basis for design of a major repair which consisted of blanketing a significant portion of the lake bottom with on-site, low-plasticity clays and clayey silts. The blanketing was completed in 1984 and post-repair filling required about two years. Subsequent monitoring and observations indicate that the lake level is holding at or within 1.5 ft of the original design normal pool.

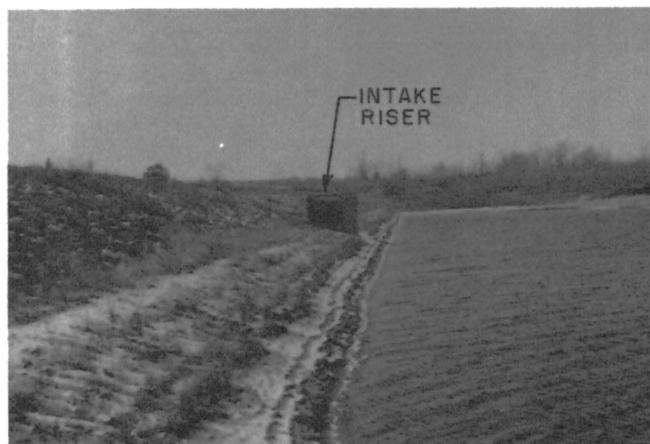
Figure 1. Pre-Repair Lake Below Intake Riser (Normal Pool) Control on Upstream Slope of Dam

Several series of post-construction test borings were drilled and groundwater observation wells were installed at intervals between 1975 and 1980. Records of lake elevations also have been maintained since 1975. Lake levels have fluctuated between Elevation 994 in October, 1977 and near the design normal pool (Elevation 1015.2) for a brief period in September, 1979. The typical lake level was well below the intake riser control level as shown in Figure 1.

Based on the remedial studies, a major repair consisting of draining the reservoir and blanketing of about half of the lake area was completed in 1984. This included a total of 416,000 cu yd of compacted blanket fill. The reservoir filled to the design normal pool within about two years and since has remained at or near that level.

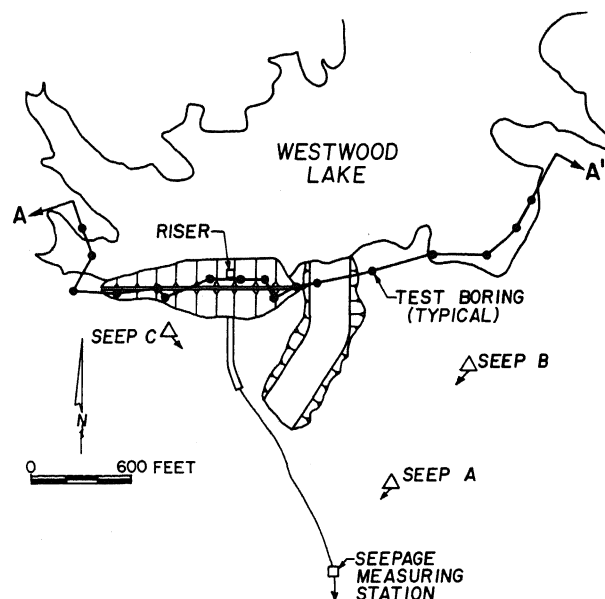
Figure 3. Locations of Site Features

These geologic considerations and test boring data suggested a southerly orientation to the granular deposits in the vicinity of the dam and abutments. The locations of several of the pre- and post-construction test borings in the vicinity of the dam are shown in Figure 3. The three seepage areas (Seeps A, B, and C) also are shown along with the seepage flow measuring station.

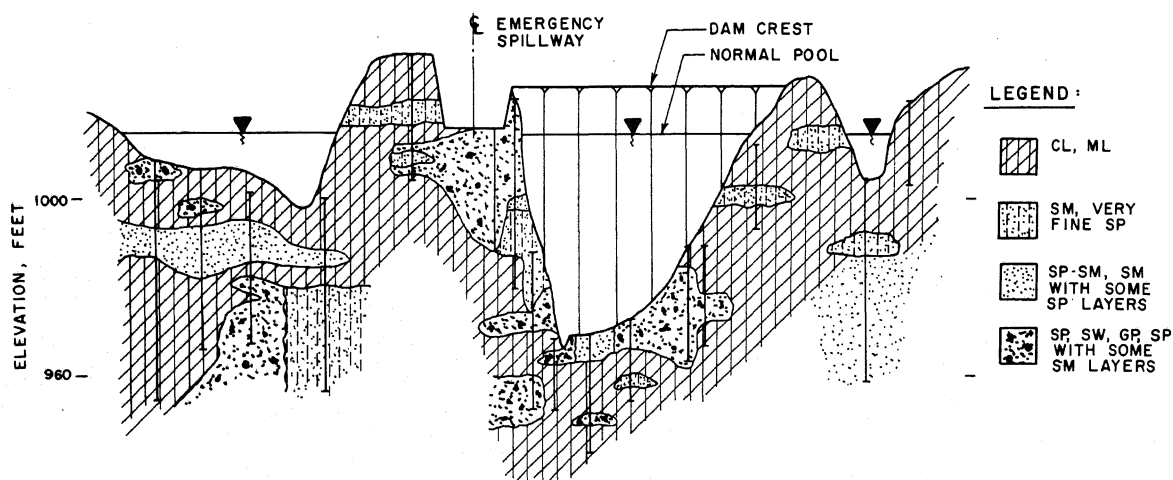
Figure 4. Subsurface Profile Beneath Dam (Section A-A', Figure 3)

A subsurface profile (east-west Section A-A') developed from these borings is shown in Figure 4. This profile illustrates the extremely complex distribution of soils with widely varying permeabilities. Within the relatively impermeable glacial till are numerous deposits or channels of granular soils. Gradations for these granular soils varied over a wide range from poorly graded coarse gravel to silty fine sands. Many of the Unified Soil Classification System groups were represented in this profile.

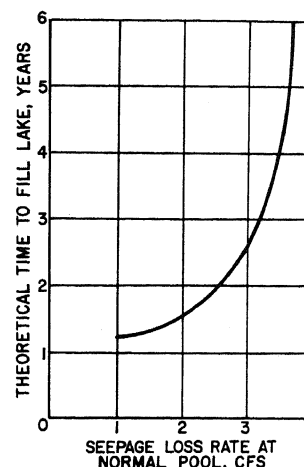
Figure 5. Theoretical Lake Filling Times

This TLS rate is consistent with Figure 5, in which the lake theoretically would not fill at a seepage loss rate of 4.0 cfs and the observation that the lake did not fill after the original construction (prior to the repair). To achieve a maximum normal pool TLS rate of 2.0 cfs (determined to be acceptable from Figure 5), it was decided to attempt to reduce the normal pool FES rate from 2.8 to 0.8 cfs, taken as a blanketing repair criterion.

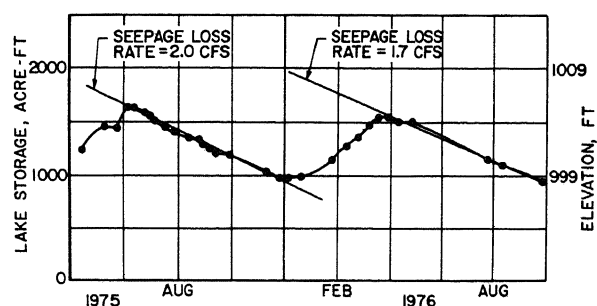
Figure 6. Total Lake Seepage (TLS) From Lake Elevation Records

From the records of lake elevation maintained after the original construction, it was possible to estimate total seepage loss rates based on the relationship between reservoir storage versus time, prior to repair, shown in Figure 6. The stream inflow was determined to be approximately equal to the evaporation loss rates during these periods.

table was developed by estimating a TLS rate of 2.0 cfs at lake Elevation 1002 from Figure 6 and a FES rate of 1.4 cfs from Figure 7. At lake Elevation 1015 (normal pool), the FES rate is 2.8 cfs, also from Figure 7. If it is assumed that the ratio between the FES and TLS rates remains constant with pool elevation, then the TLS rate would be about 4.0 cfs at the normal pool level.

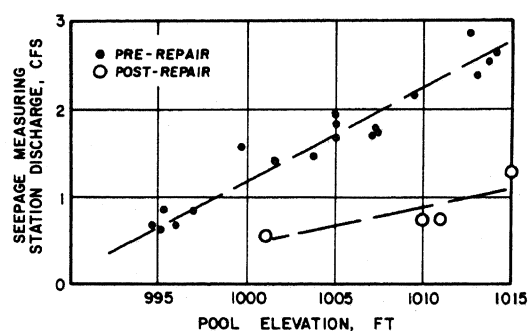
Figure 7. Measured Front End Seepage (FES), vs. Lake Elevation

Results of the observed flow at the downstream seepage measuring station are summarized in Figure 7. It can be seen that the pre-repair points (solid circles) essentially form a linear relationship with the lake elevation. The pre-repair data were also utilized to estimate the portion of the "total lake seepage" (TLS) that exited the lake through granular deposits in the foundation and abutments and was monitored downstream of the dam. This is hereafter referred to as "front end seepage" (FES). At the normal pool Elevation 1015, an FES seepage rate of 2.8 cfs was measured. A limited number of post-repair data points also are shown in Figure 7 as open circles.

During refilling, the seepage flow re-emerged, at a low rate, at Seep B. The available post-repair seepage flow measurements as shown in Figure 7 indicate that the FES level was reduced from its original normal pool rate of 2.8 to 1.2 cfs, but not to the intended design level of 0.8 cfs.

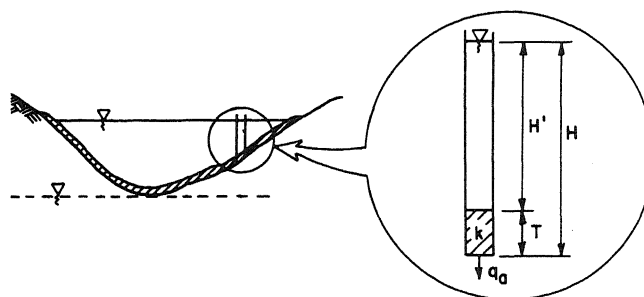
Figure 8. Idealized Seepage Model for Blanket

The blanket thickness was determined using the idealized model shown in Figure 8 and the ensuing theoretical Equation (1) derived from Darcy's Law. This model assumes complete head loss through the blanket and is generally conservative for most locations in the lake area as compared to a more comprehensive analysis that assumes head loss through the blanket and underlying natural soils.

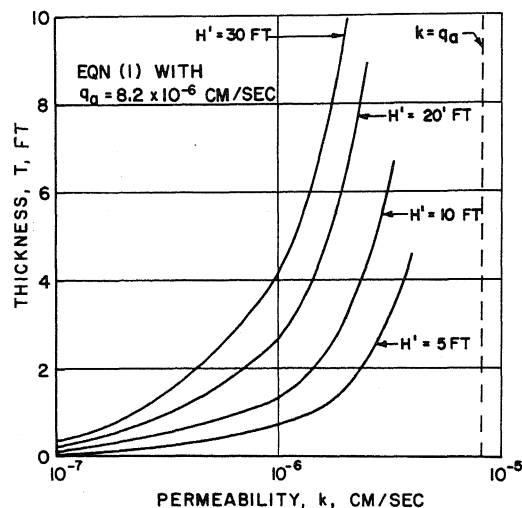
Figure 9. Blanket Thickness vs. Permeability

The value for q_a was determined by dividing the allowable normal pool FES seepage criterion of 0.8 cfs, as established in the preceding section, by the estimated contributory area to the FES. Design relationships between the parameters in this equation are shown in Figure 9 illustrating the sensitivity to the design k-value. It can be seen that if the field k-value is on the order of 10^{-7} cm/sec, then the blanket thicknesses based on $k=1 \times 10^{-6}$ cm/sec are very conservative. On the other hand, if k

approaches 10^{-5} cm/sec, the blanket is pervious and would serve no useful purpose.

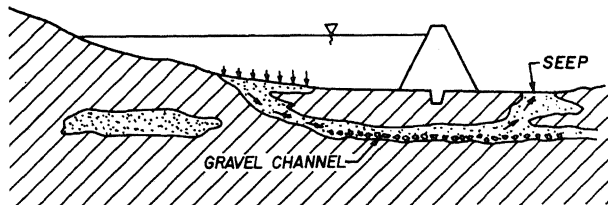
Figure 11. Possible Seepage Flow Path

upstream of the dam, suggested by the downstream location of Seep A and as depicted in Figure 11, led to the decision to extend the blanketing to a point about midway in the lake, as shown in Figure 10. This also provided a margin of safety considered appropriate in light of the very approximate nature of the above analyses.

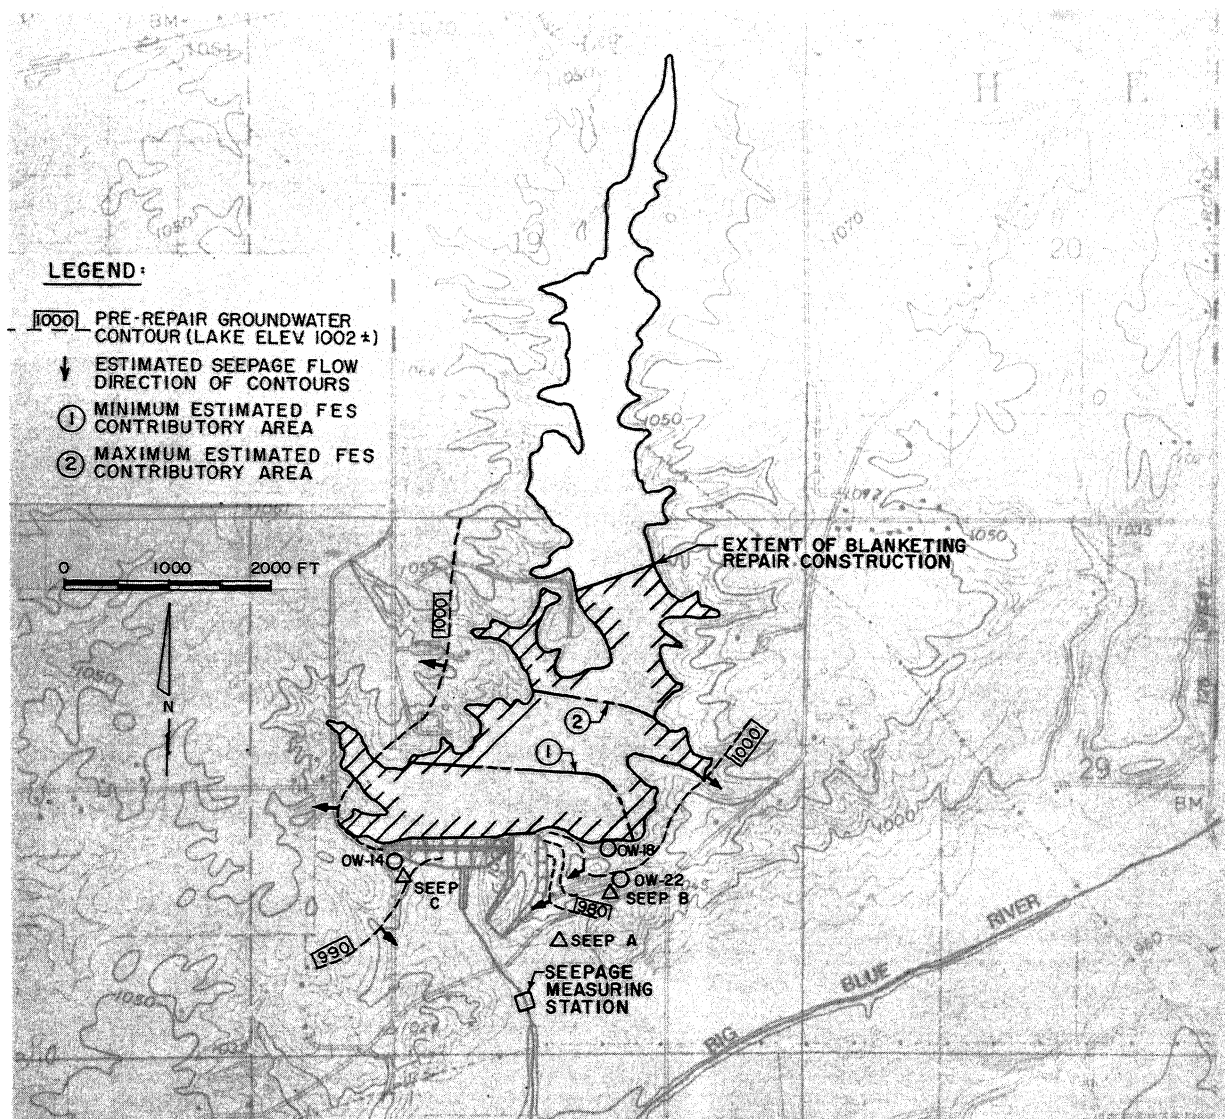
Figure 10. Estimated FES Contributory Areas and Extent of Blanketing

The extent of the contributory area to FES seepage was estimated based on the locations of Seeps A, B, and C, measured groundwater levels in observation wells, regional topography, and water well data. Although regional flow nets were judged to be only marginally applicable to such a heterogeneous soil deposit, probable flow directions were determined from the pre-repair groundwater contours as shown in Figure 10. Possible maximum and minimum FES contributory areas were estimated from these analyses. The possibility of extremely permeable coarse granular strata extending well

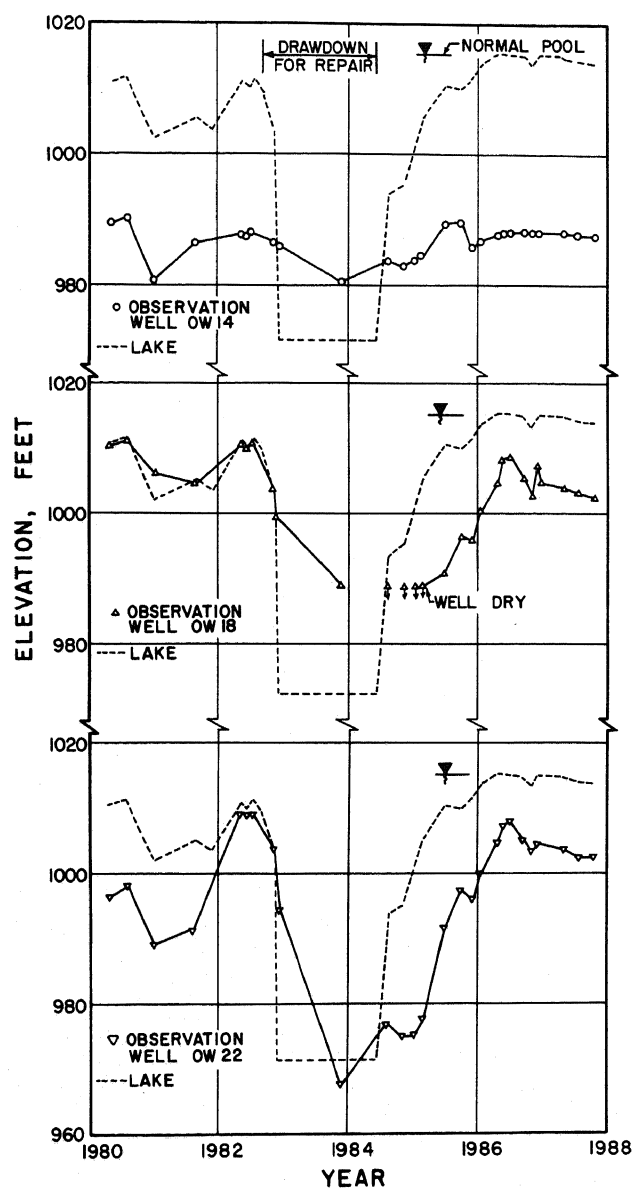
Figure 12. Measured Pre- and Post-Repair Groundwater Levels in Three Observation Wells

In general, the observation well readings were erratic, as would be expected for these conditions. However, some insight to the blanket performance is indicated by the readings in three typical groundwater observation wells, OW-14, OW-18, and OW-22, judged to be responsive to the lake levels before and after the blanketing repair, at locations shown in Figure 10. These readings are plotted in Figure 12. The before and after readings for OW-14 and OW-18 indicate an increased head loss or degree of separation between the lake and groundwater after the repair. The same holds true for OW-22 for lake levels above Elevation 1000.
